<b>Title: NXT Main Tube Output PCB</b>			Steelpark Road Coombs Wood Industrial Estate West Halesowen UK <a href="http://www.laney.co.uk">www.laney.co.uk</a>
<b>Size: A3</b>	<b>Number: 9418</b>	<b>Revision: 3</b>	
<b>Date: 20/02/2008</b>	<b>Time: 14:31:09</b>	<b>Sheet 1 of 1</b>	
<b>Original File: 9418.SchDoc</b>

Title: NXT Tube Status Monitor		
Size: A3	Number: 9425	Revision: 2
Date: 23/11/2007	Time: 11:20:25	Sheet 1 of 1
Original File: 9425.SchDoc

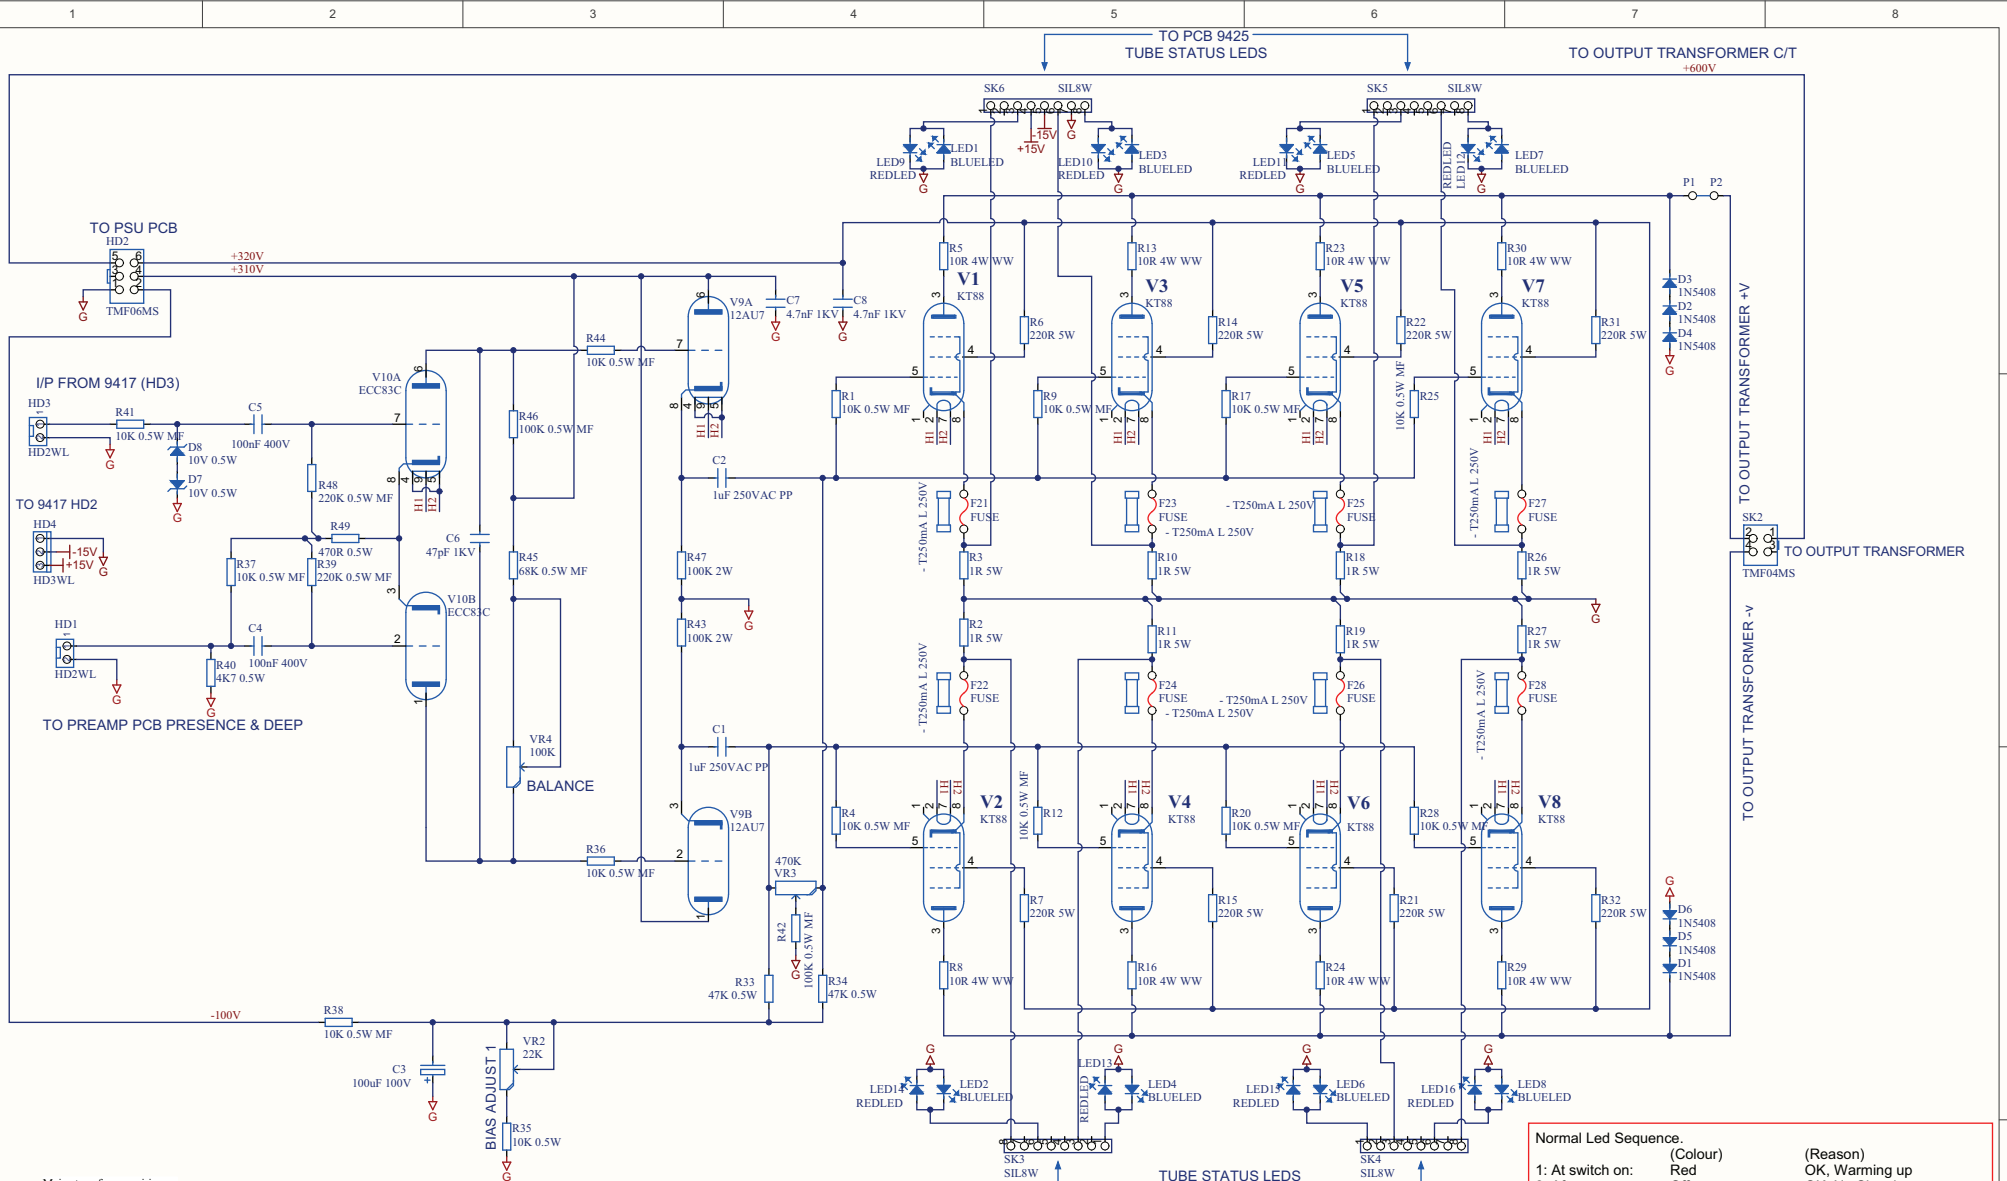
**Normal Led Sequence.**

(Colour)	(Reason)
1: At switch on:	Red	OK, Warming up
2: After warm up:	Off	OK, No Signal
3: Signal present:	Flashing Blue	OK, Signal Present

**Fault Conditions.**

1: After warm up:	Red	Faulty tube and/or fuse failure. (If all tubes, bias may be wrongly set)
2: After warm up:	Blue	Faulty tube (If all tubes, bias may be wrongly set)
